SECTION III

ARCHITECTURAL IMPACT

OF PROTECTIVE GLAZING

Aesthetic Impact of Protective Glazing

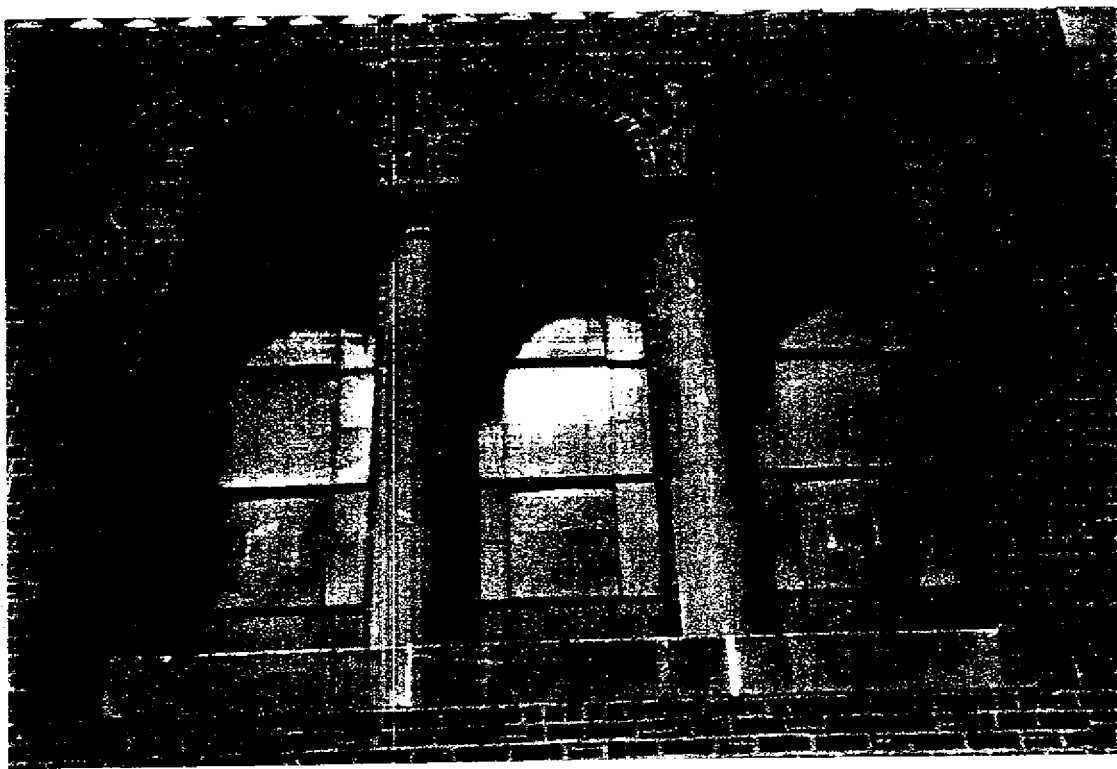
Fig. 26. Due to cloudy PG, these windows no longer read as apertures in the wall.

Plastics are also susceptible to glare but their primary downfall is that when exposed to sunlight and weather, over time all plastics will cloud and yellow. Cloudy PG appears almost opaque, more like a painted surface than a window. Out of 60 plastic PG installations surveyed, only those installed in the past few years still had reasonable clarity. Manufacturers recognize this chronic problem and do not warranty their products beyond a few years. Plastics are also difficult to clean since they scratch easily. **In terms of aesthetics, all plastic products are a poor investment.** The appearance of a plastic installation is certain to decline in a relatively short period of time.
